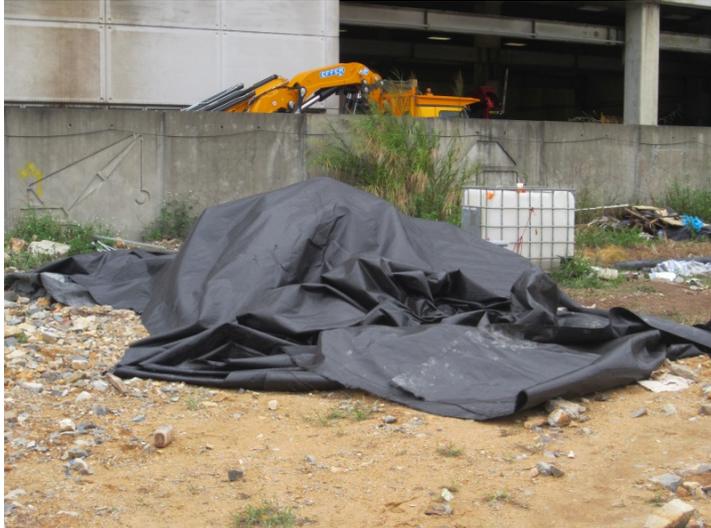
*Photo 1 – Impermeable sheets were observed to have been placed on the stockpiles of excavated soils and rocks that were not in use.*

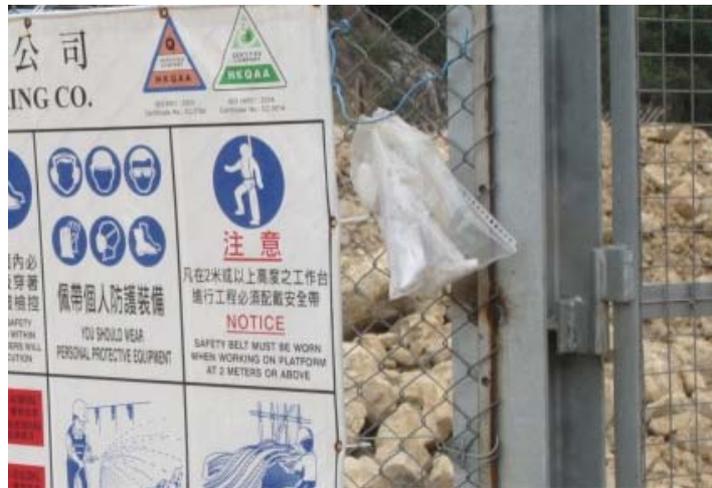
*Photo 2 – The EP copy displayed at the vehicular site entrance was damaged.*

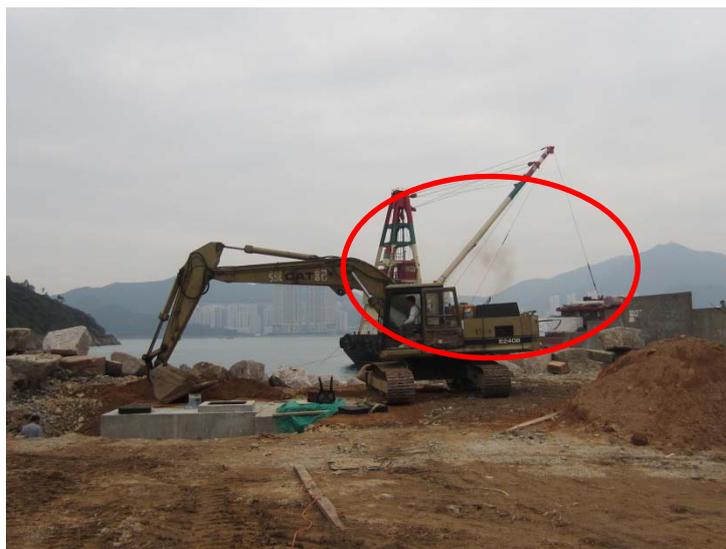
*Photo 3 – Dark smoke was seen rising from the crane truck used to backfill the excavated rocks and soils.*
