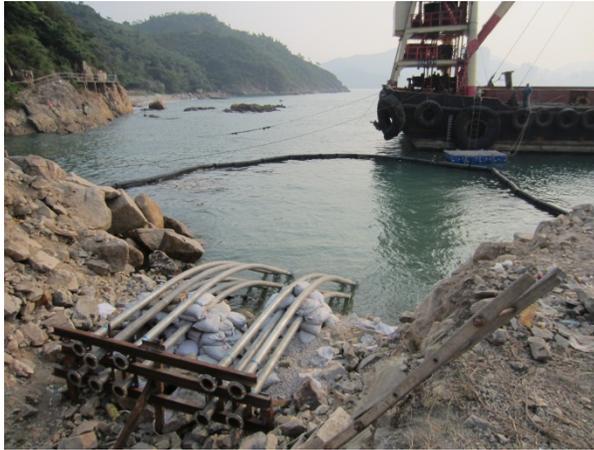
*Photo 1 - A silt curtain was employed around the seawall area.*

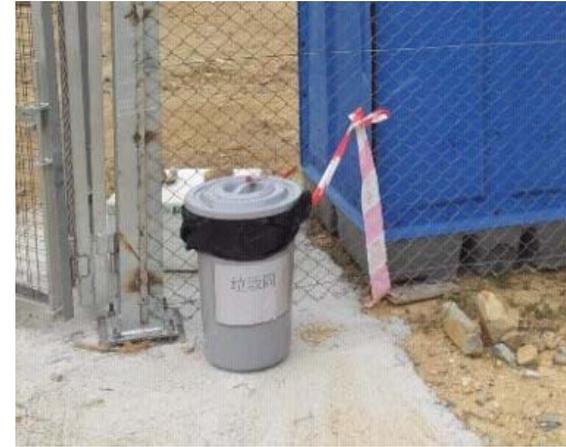
*Photo 2 - A rubbish bin was placed on site in the next day of site inspection.*

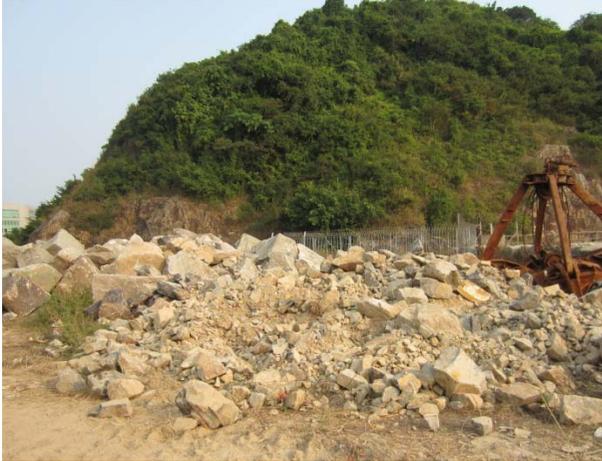
*Photo 3 - Tarpaulin sheets to cover dusty stockpiles to prevent dust generation were absent from the construction site.*
