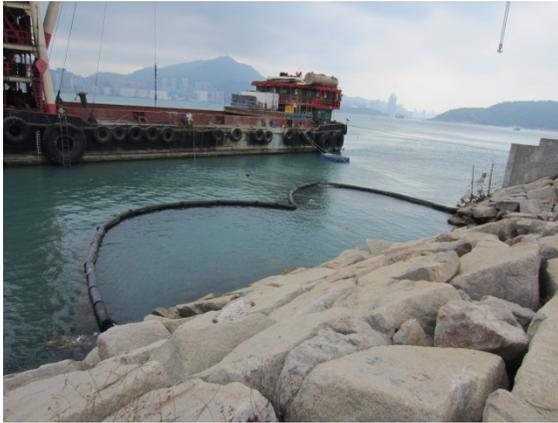
*Photo 1 - A silt curtain was employed around the seawall area.*

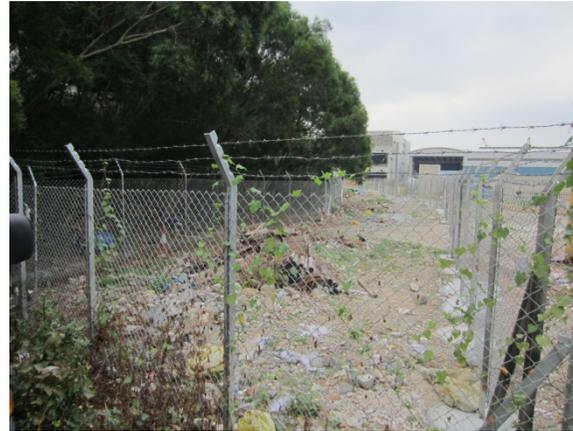
*Photo 2 - Fences were erected along both sides of the land duct alignment*

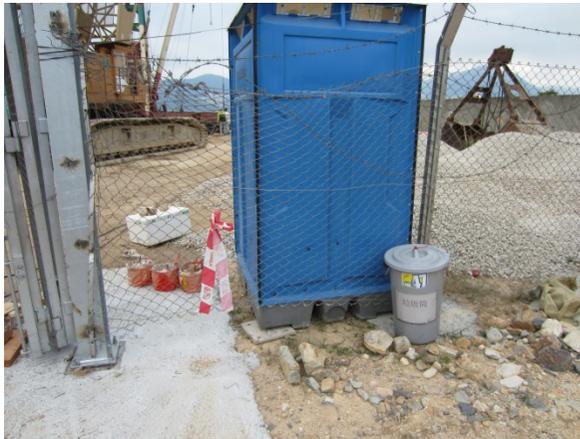
*Photo 3 - A rubbish bin was provided by the Contractor*

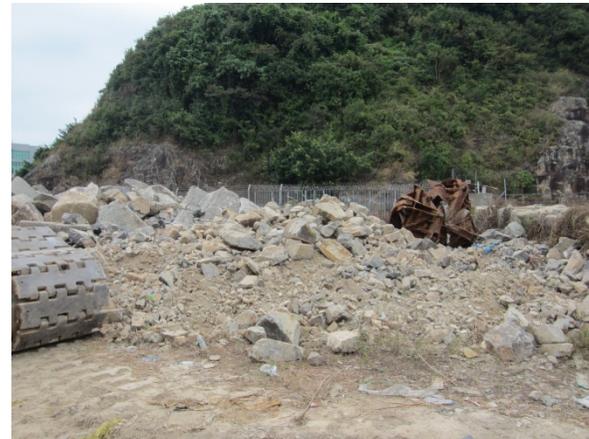
*Photo 4 - Tarpaulin sheets to cover open stockpiles to prevent dust generation were absent from the construction site.*
