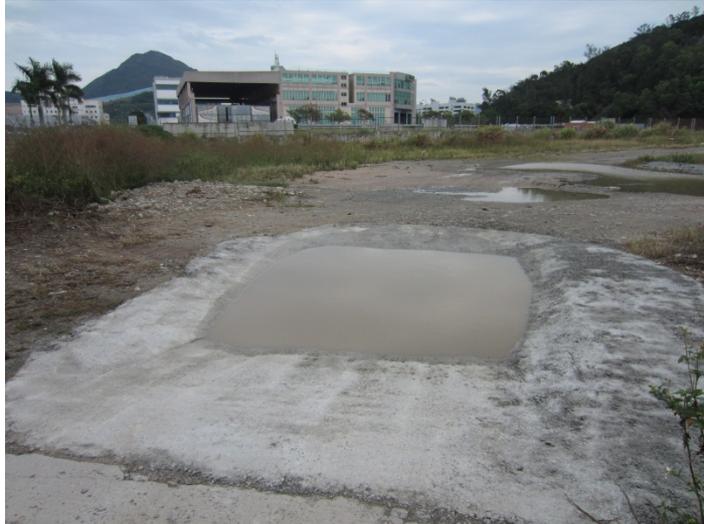
*Photo 1 - A wheel-washing bay was available at the construction exit.*

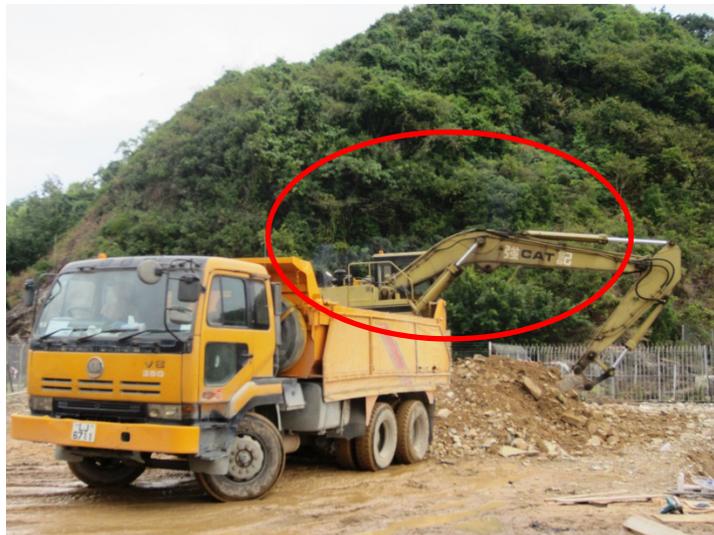
*Photo 2 - Dark smoke was seen rising from the crane truck.*

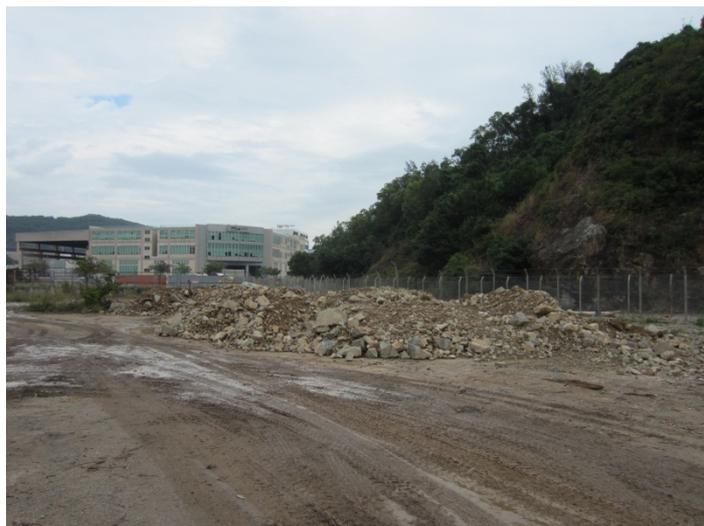
*Photo 3 - Stockpiles of the excavated materials were observed to be exposed.*
