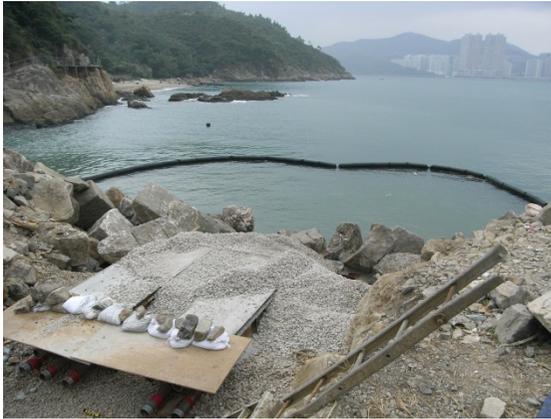
*Photo 1 - A silt curtain was employed around the seawall area.*

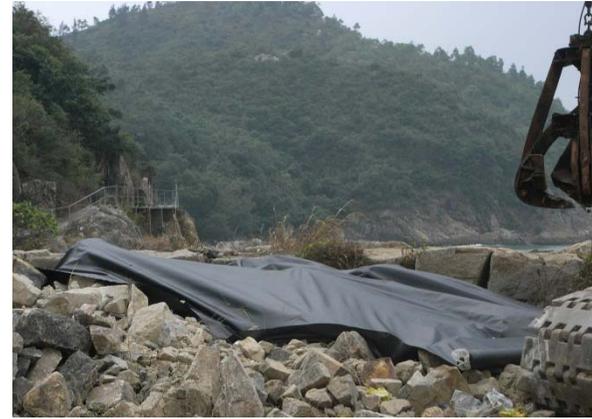
*Photo 2 - Tarpaulin sheets were observed to have been used to cover excavated materials for the part that was not actively used.*

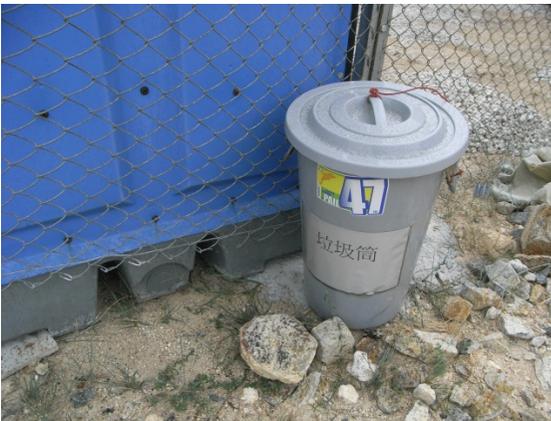
*Photo 3 - A rubbish bin was provided by the Contractor.*

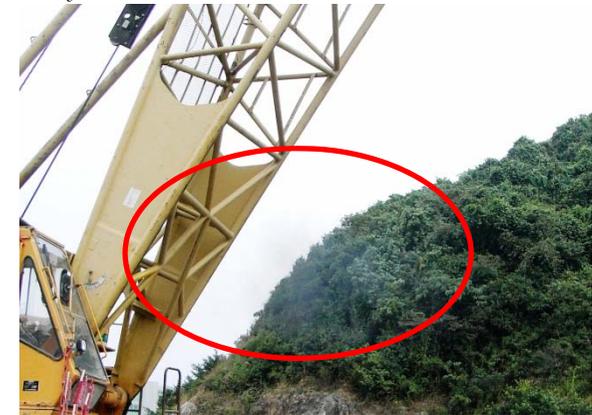
*Photo 4 - Dark smoke was seen rising from the crane truck used to restore large boulders to the opened sea wall.*
