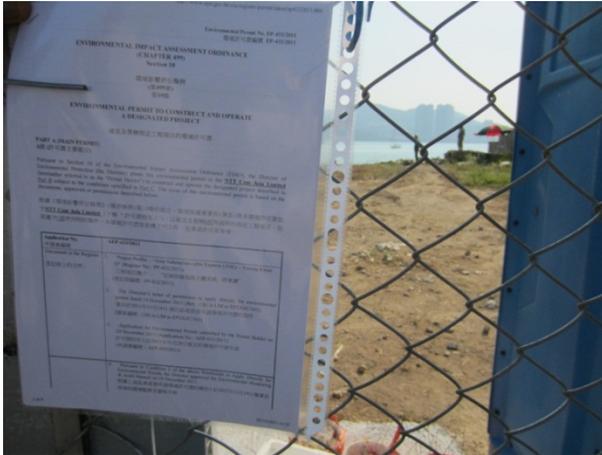
*Photo 1 - A copy of EP was displayed conspicuously at the vehicular site entrance.*

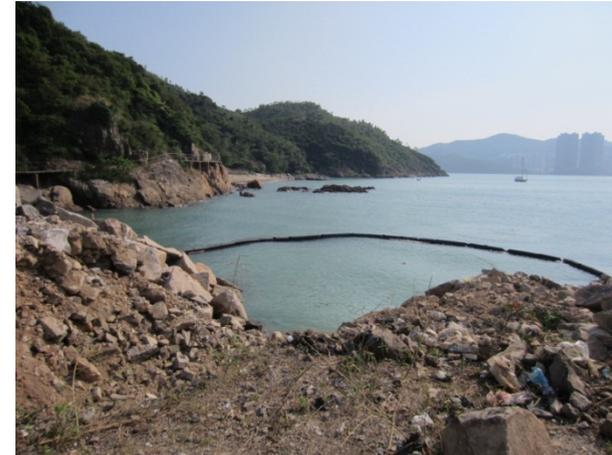
*Photo 2 - A silt curtain was employed around the seawall area.*

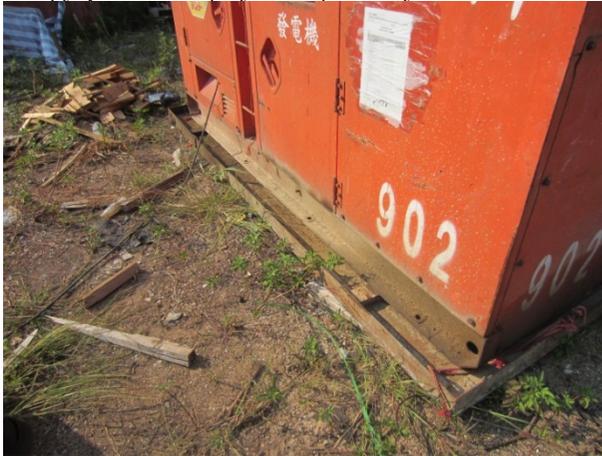
*Photo 3 - A dip tray was provided for the generator that potentially has oil leakage.*

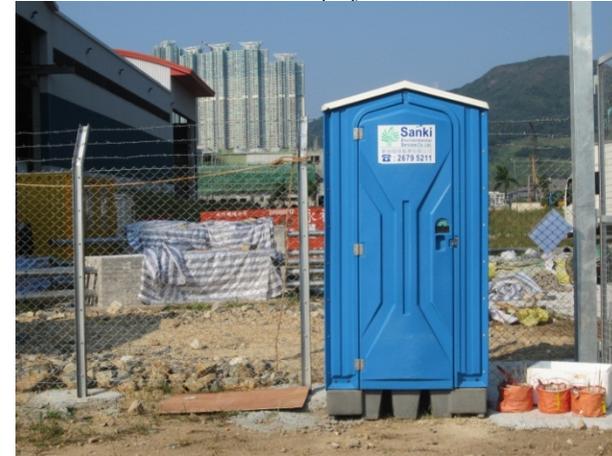
*Photo 4 - Portable toilet was provided on the construction site.*
