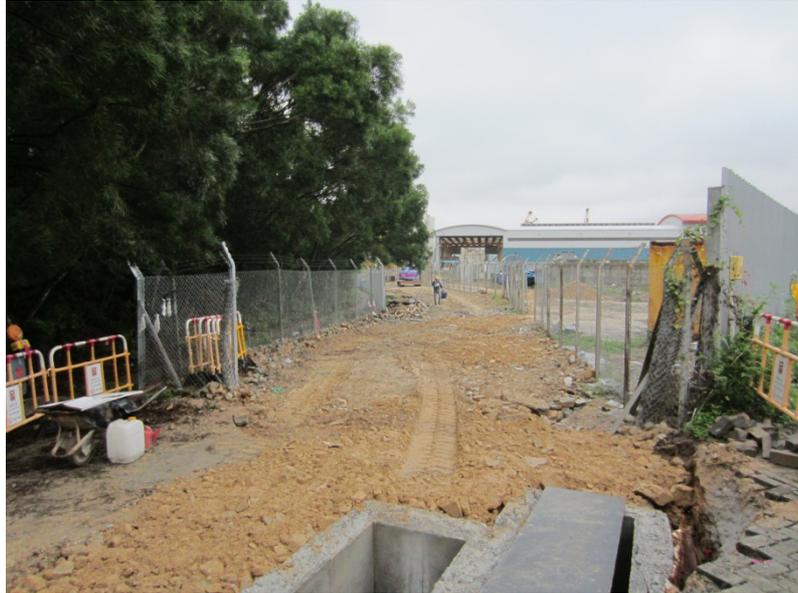
*Photo 1 – For the completed section of land duct, excavated materials have been backfilled and the site has been reinstated to its original status.*

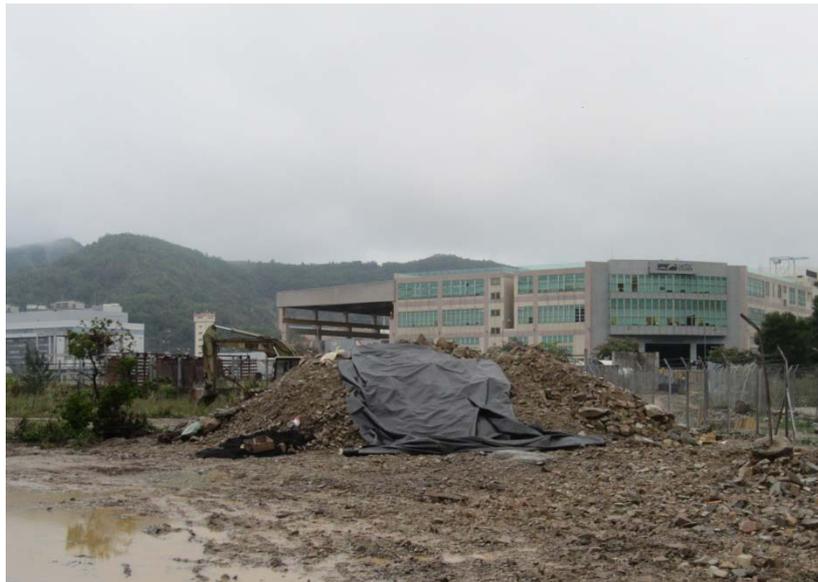
*Photo 2 – Some stockpiles of the excavated soils from the new beach manhole and land duct were partly exposed in the rain.*
